Static Firing Data and Discussion: Tropos 2 Sugar Motor 14 Sep 09

Tropos 2 Sugar Motor Static Test

14 Sep 2009

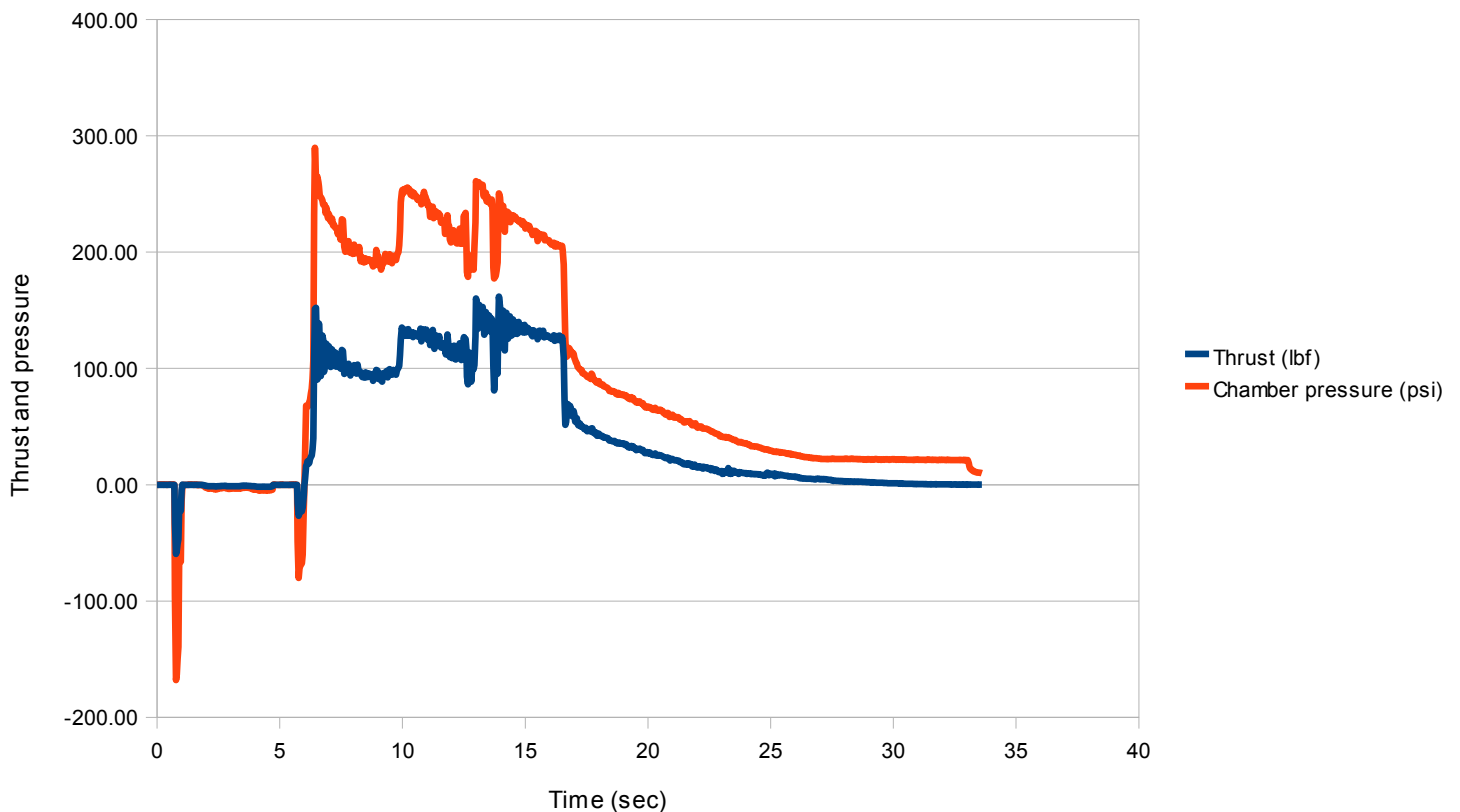
The negative spikes on the plot correspond to the igniter firing and valve opening. The igniters, valve, and data system were all run from the same battery, and presumably the negative spikes were from momentary drops in voltage during igniter firing and valve opening.

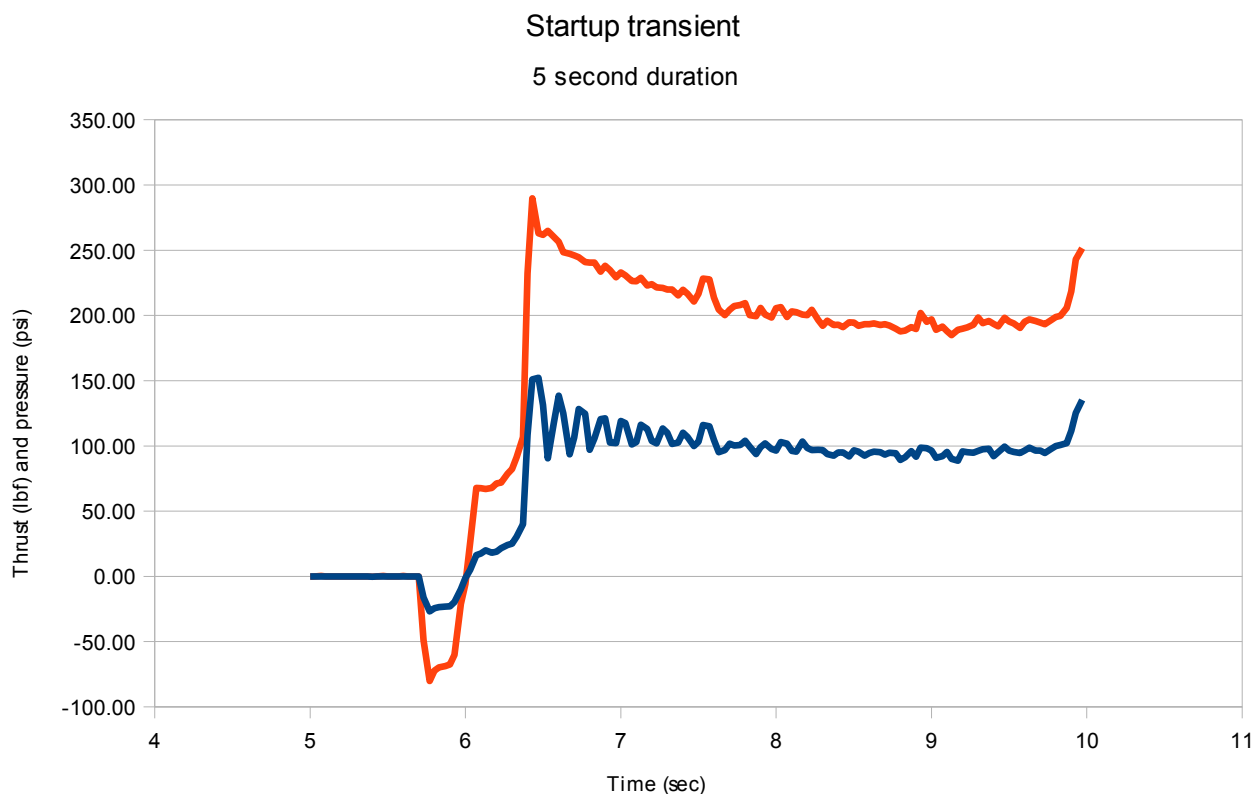
The thrust data again showed a 4-5-Hz oscillation immediately after the motor ignited, and it damped out after about 1 second. Since a different test stand was used this time, it does not appear to be

something mechanical with the thrust stand as was previously surmised. The cause of this oscillation is still unknown.
